## Repair Examples

## TRAC Structural Ltd

## Structural Timber Repairs

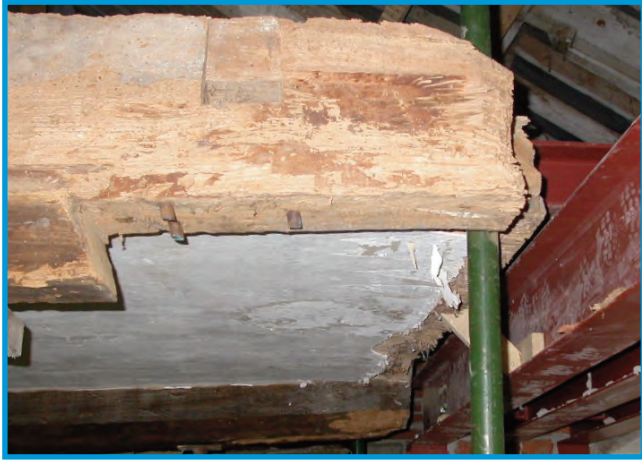
Preparation of an original scarfed beam end. The beam was subsequently reconstructed into the web of the new steel beam

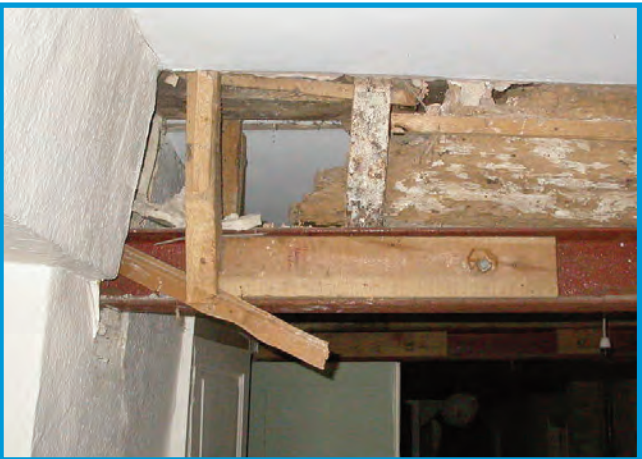
Investigation revealed that an original beam had totally failed and had been supported on steel prior to boxing in by a previous owner. The beam was repaired in-situ and the steel support removed

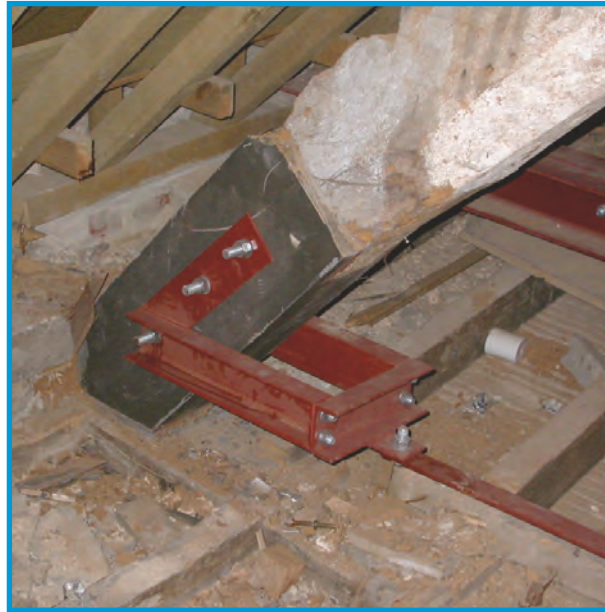
An original roof truss had rotted and the roof had spread. The foot of the truss was completely reconstructed in resin and provided the connection point for a new tie bar to stop the spread

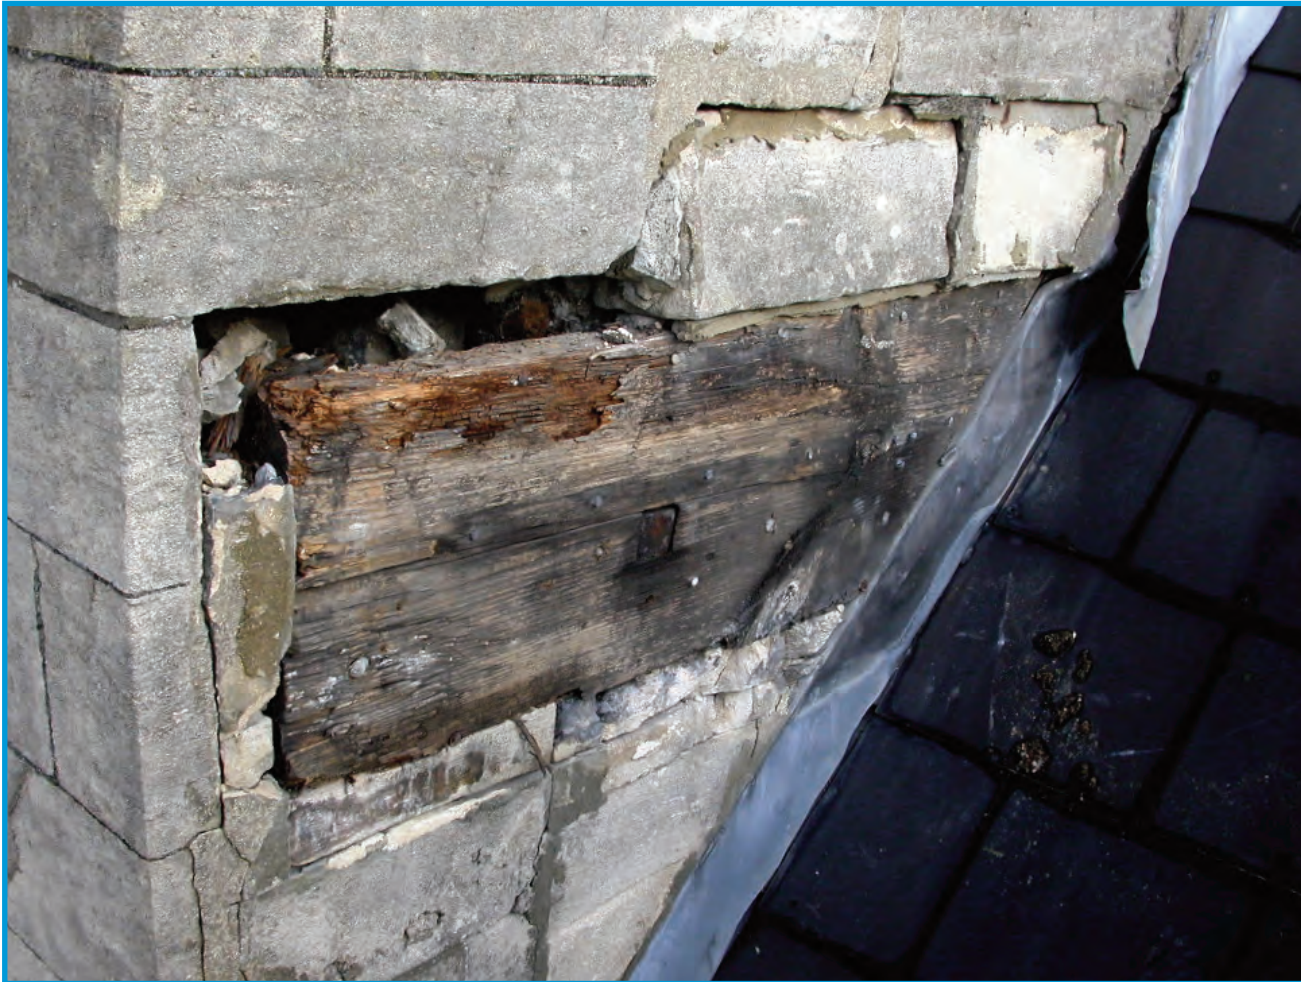
## Brunel Lodging House Former Swindon Railway Museum

The end of the timber Bressumer has partially rotted and the movement of the masonry around the timber is clearly evident.

An in-situ repair was carried out by TRAC Structural Ltd in November 2008.

The masonry was first stabilised using the **Helifix System** of reinforcement.

With the load removed from the failed section of the Bressumer, an in-situ Rotafix System repair was carried out

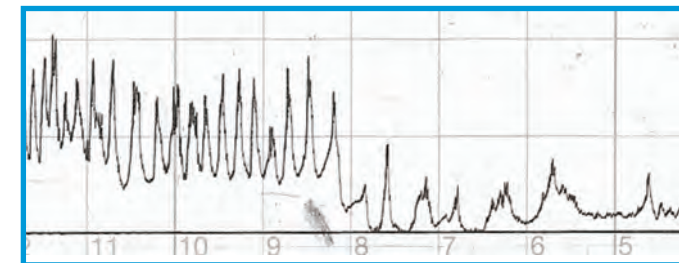
## Resistograph Investigation

Resistograph examination provides a print out showing the location of damage to the timber prior to works being carried out
